POST-DISASTER SURVEY FINDINGS FROM THE 2009 PADANG EARTHQUAKE

01.2010

By Dr John E. Alarcon

THE 30TH SEPTEMBER 2009 PADANG, SUMATRA, EARTHQUAKE

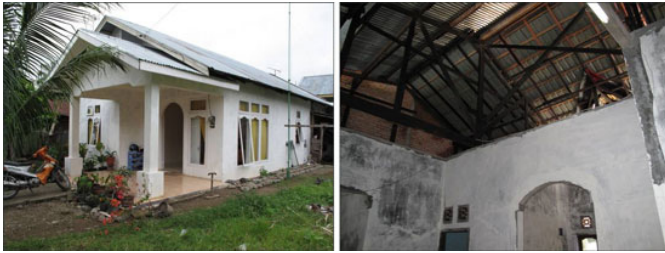
Damage to residential structures was not widespread, with the most severe damage concentrated in certain areas of Padang city and towns in Pariaman regency. Residential structures here are predominantly one- to two-storey high buildings constructed of confined masonry. Since temperatures in the region average 27°C throughout the year, houses typically have high ceilings for ventilation purposes, with roofs composed of wood frames with corrugated-galvanised iron sheets fixed on top (Figure 3). These light-weight roofs significantly reduce lateral inertia compared to structures with concrete slab roofs, and their ubiquity is one of the reasons for the relatively low damage ratios to residential structures, most of which are uninsured against the earthquake peril. In low-income areas or in small villages, unreinforced masonry (URM) and wooden houses, or a mixed of masonry and wood, were also observed. Here, URM buildings sustained significantly more damage than wood frame houses. By contrast, wealthy sectors of Padang and Pariaman have a number of houses constructed of moment resisting frames with infill walls, which experienced various degrees of shear cracking.

Figure 3: Residential house in Padang (left) and typical roof configuration (right). (Source: AIR)

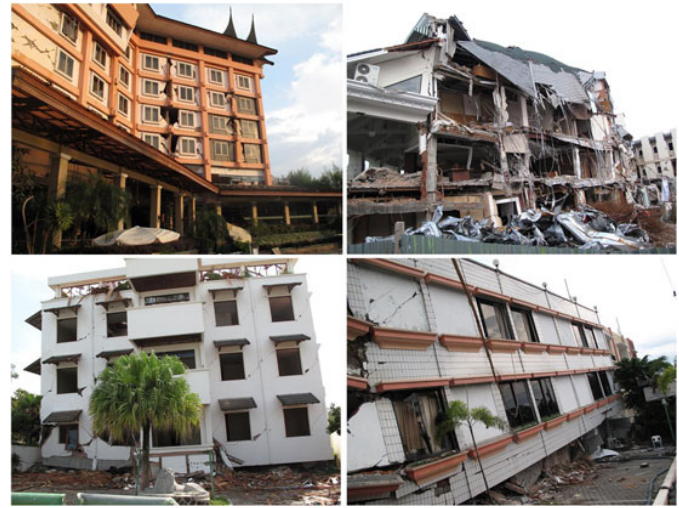
Commercial buildings in Padang can be divided into two categories: small to medium retail trade businesses such as those found in Padang’s Chinatown, and large commercial business mainly represented by hotels and large shopping centres. Businesses in the first category occupy structures similar to the residential building stock and thus large numbers of collapsed structures were not observed; rather, most of the observed exposures exhibited no or only moderate damage. On the other hand, a significant number of large commercial structures, mainly of moment-resistant frames of reinforced concrete (RC), suffered significant damage or even collapse. The predominant failure mechanism of RC structures was soft storey failure. Many of these buildings provide public access at the street level; if these accesses involve large openings for garages or commercial space, they can, if not properly taken into account in the design process, lead to pancake-style collapses of the ground floor.

The second cause of observed failures in RC buildings was the result of poor reinforcement in columns, particularly in terms of spacing of links in the column/beam joints.

Figure 4: Examples of severe damage and collapse of Hotels in Padang. With the exception of the Bumiminang Hotel (top left) that suffered severe damage to infill walls, though the structural elements behaved generally well, most failures in hotel structures occurred due to soft storey failure, as shown in the other panels. (Source: AIR)

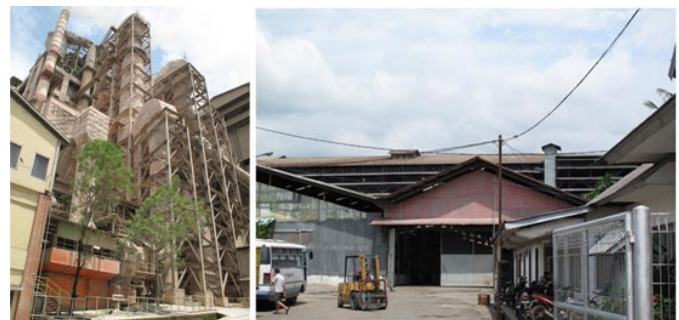
Industrial buildings performed very well during the earthquake, with most industrial facilities showing little or no structural damage. However business interruption played an important role since for all practical purposes all production in Padang stopped for a week due to electrical power cuts (service in Padang was cut as a precaution against fires igniting due to short circuits). Even after power was restored, machinery had to be recalibrated before start-up; nearly 40 days after the event, most industrial production had not yet reached 100% of pre-earthquake levels.

Figure 5: Cement plant (left) and rubber plant (right) in Padang. Only minor damage was observed, though business interruption was likely an issue for these insured facilities. (Source: AIR)

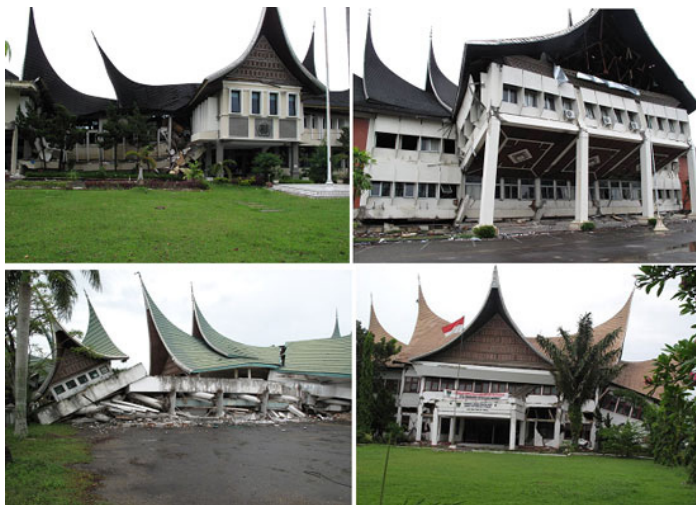
Governmental buildings, most of them three- to five-storey high RC structures, suffered severe damage. According to senior engineers from Bung Hatta University, about 80% of governmental buildings in Padang were severely damaged or collapsed. As in the case of hotels, the principal cause of failure in governmental buildings was due to soft storey failure.

Figure 6: Collapse of governmental buildings in Padang, caused by soft storey effects. (Source: AIR)
