POST-DISASTER SURVEY FINDINGS FROM THE 2009 PADANG EARTHQUAKE

01.2010

THE 30TH SEPTEMBER 2009 PADANG, SUMATRA, EARTHQUAKE

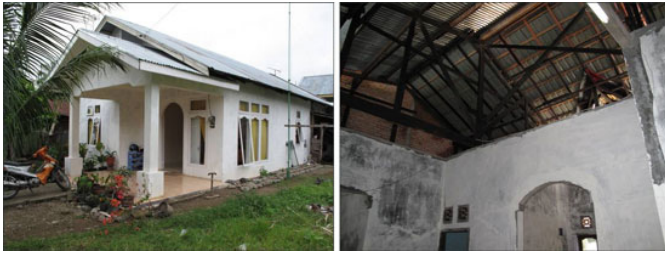
Damage to residential structures was not widespread, with the most severe damage concentrated in certain areas of Padang city and towns in Pariaman regency. Residential structures here are predominantly one- to two-storey high buildings constructed of confined masonry. Since temperatures in the region average 27°C throughout the year, houses typically have high ceilings for ventilation purposes, with roofs composed of wood frames with corrugated-galvanised iron sheets fixed on top (Figure 3). These light-weight roofs significantly reduce lateral inertia compared to structures with concrete slab roofs, and their ubiquity is one of the reasons for the relatively low damage ratios to residential structures, most of which are uninsured against the earthquake peril. In low-income areas or in small villages, unreinforced masonry (URM) and wooden houses, or a mixed of masonry and wood, were also observed. Here, URM buildings sustained significantly more damage than wood frame houses. By contrast, wealthy sectors of Padang and Pariaman have a number of houses constructed of moment resisting frames with infill walls, which experienced various degrees of shear cracking.

Figure 3: Residential house in Padang (left) and typical roof configuration (right). (Source: AIR)
