OBSERVATIONS FROM THE MAGNITUDE 6.3 L'AQUILA EARTHQUAKE

05.2009

By Drs. Paolo Bazzuro, Guillermo Franco and John Alarcon

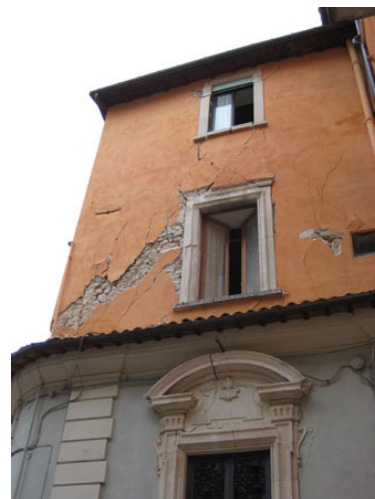
Facades of masonry structures still standing showed cracks varying in severity, from loss of plaster to separation of the walls from the structure (Figure 4). In this latter case, the structural integrity of the wall, the load-bearing system, is compromised and such buildings will likely be demolished. In isolated cases, the collapse of masonry structures in the old center of L'Aquila was complete. Partial structural collapses of walls or cornices were more frequent.

Figure 4. Severe cracks compromise the structural integrity of the wall. Source: AIR

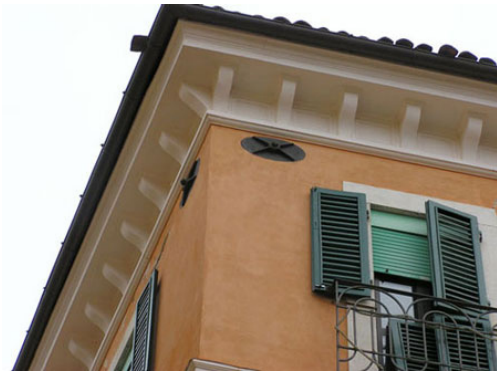
Masonry structures that displayed cross-ties (catena in Italian) as in Figure 5, showed a much better resistance, provided that the lateral walls were properly reinforced.

Figure 5. Effective mitigation devices include cross-ties ("catena" in Italian). Source: AIR

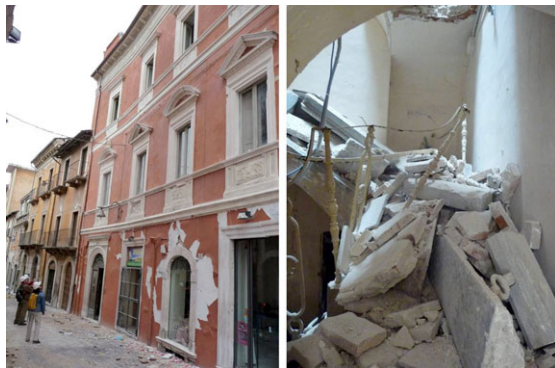
However, in some cases, although the building seemed to be largely intact from the outside, the inside revealed devastation (Figure 6).

Figure 6. From the exterior, this URM building looked relatively unscathed; the interior (on the right) revealed otherwise. Source: AIR

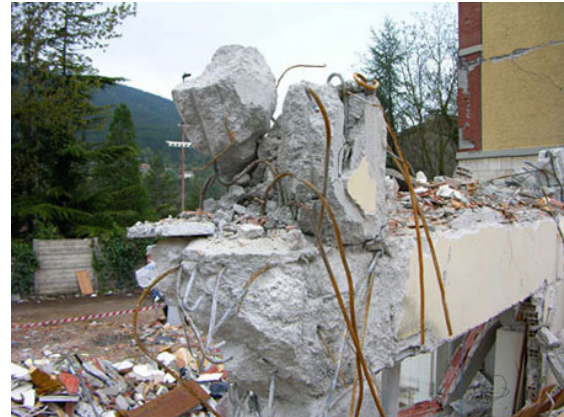
The large majority of reinforced concrete (RC) buildings fared well considering they were subjected to a ground motion equal to or greater than that for which they were originally designed. However, in older building code specifications, column-beam connections were allowed to be designed with smooth rebar that provide insufficient bonding with the concrete. The consequences are shown in Figure 7. Some failed connections also displayed widely-spaced small-diameter stirrups, which cannot prevent the buckling of longitudinal rebar in columns. Together, these were the cause of most of the RC collapses that the team observed in the field, such as those shown in Figure 8.

Figure 7. Smooth rebar allowed under older code provide insufficient bonding with the surrounding concrete. Source: AIR

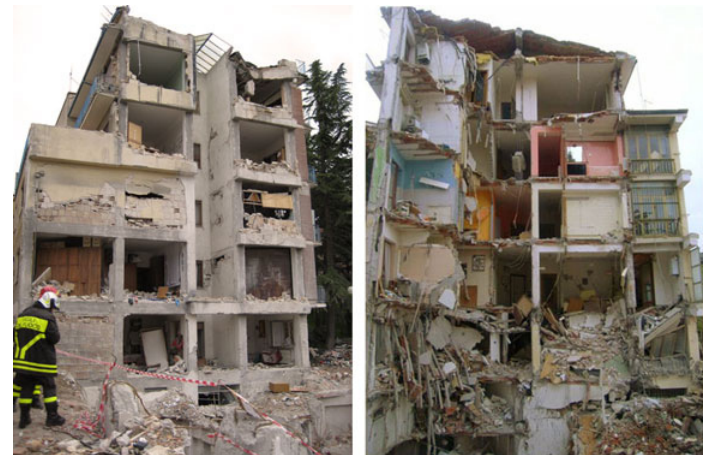
Figure 8. Total and partial collapses of older RC buildings in L'Aquila. The collapse of the university dormitory on the right resulted in the deaths of eight students. Source: AIR

Perhaps one of the most publicized collapses was that of a wing of a university dormitory built in the 1970s—again likely the result of shoddy construction.

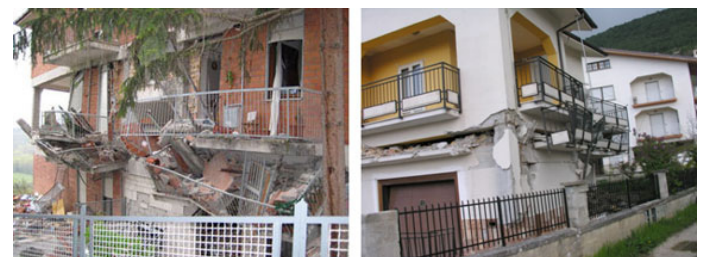
Figure 9 shows dramatic pancake collapses of the third onto the second story of two RC buildings due to the failure of all the beam-column connections (as described above). Note the balconies, which are now one on top of the other. In the photo on the right, note the identical building behind, which experienced damage at the first floor but not at the second.

Figure 9. Pancake collapse due to beam-column connection failure. Source: AIR and Paolo Clemente (EERI team)

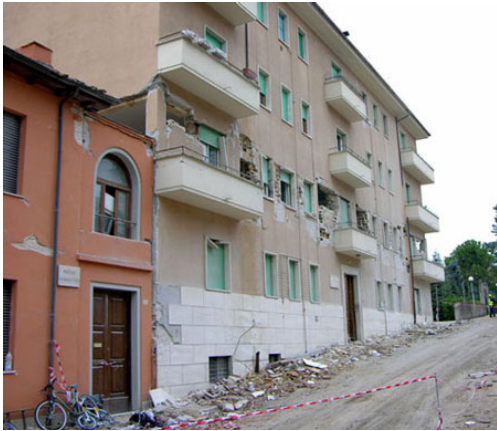
Pounding—a phenomenon in which two adjacent buildings hit each other during an earthquake because they are too close together and have different natural periods of vibration—was another damage mechanism encountered during the survey. Figure 10 shows a textbook example of pounding. The roof of the 2-story building hit the column of the adjacent 4-story structure causing the failure of all the columns at that level. Note that the first, third and the fourth story essentially show no damage.

Figure 10. Classic example of damage due to pounding. Source: AIR

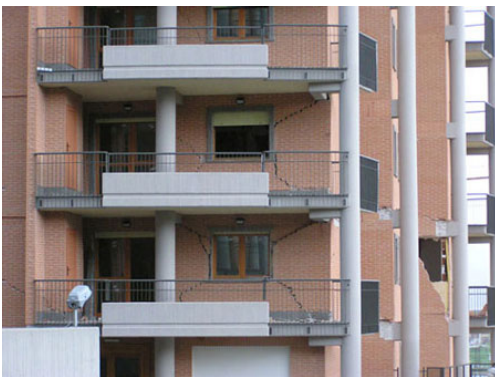
Modern RC frame buildings (i.e., those designed after 2003 when the last building code was issued) fared much better than those built in the 1960s through the 1980s. They generally suffered no exterior damage or perhaps minor to moderate damage to exterior infill walls and interior partitions. Figure 11 shows a typical example of shear cracking to brick infill; while this building will be costly to repair, there is no damage to the underlying concrete frame.

Figure 11. Reinforced concrete buildings designed after the most recent code (2003) fared much better than their older counterparts. Source: AIR

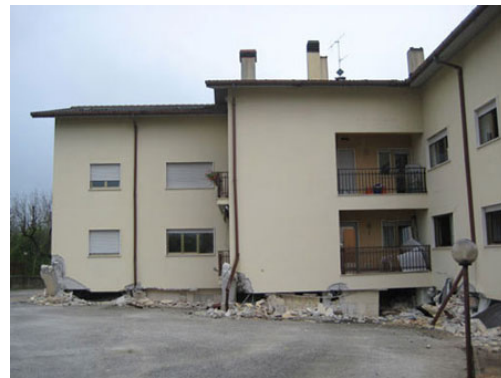
In the town of Pettino, 3 km (1.86 mi) north of L'Aquila, the survey team found several instances of both pancake collapses and soft-story effects. In one cluster of four almost identical buildings, two collapsed as a result of soft-story failure and two survived—a stark example of the uncertainty that must be taken into account when modeling building vulnerability. Figure 12 shows one of the collapsed buildings, whose columns on the ground floor, which was used for parking, failed—a classic example of soft-story failure. While such buildings can certainly be designed to withstand ground shaking, in this case, the ground-floor column-beam connections displayed insufficient stirrup reinforcement (large spacing and small diameter) and short anchorage lengths of the beam longitudinal rebar in the column.

In order to avoid soft story effects, Eurocode does not allow differences in the rigidities of the frame (beams and columns) between adjacent stories to be larger than 25%. However, most of the soft story failures seen in Abruzzo were the result not of differences in the frame, but rather as a result of the ground floor having open bays and the floor above having infill walls. Eurocode does not specify directly that infill masonry walls must be taken into consideration during the rigidity analysis, nor does it specify how such consideration might be undertaken.

Figure 12. Soft-story failures were observed in the town of Pettino, which sits on soft soils. Source: AIR

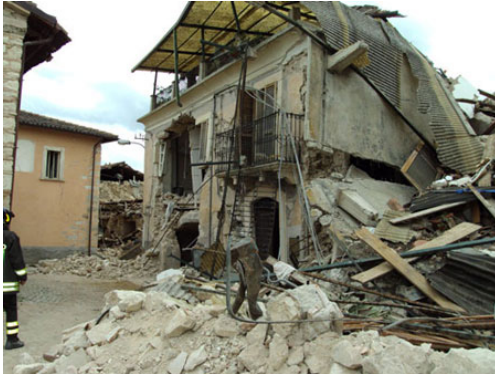
Onna, located about 7 km (4.3 mi) southeast of L'Aquila and entirely on alluvial soils, suffered the heaviest damage of any town visited, with collapse or partial collapse of a large proportion of its masonry structures (Figure 13). Three weeks after the earthquake, when these photos were taken, the entire population of the town remained under evacuation orders.

Figure 13. Partial and total collapse of masonry structures in Onna. Source: AIR

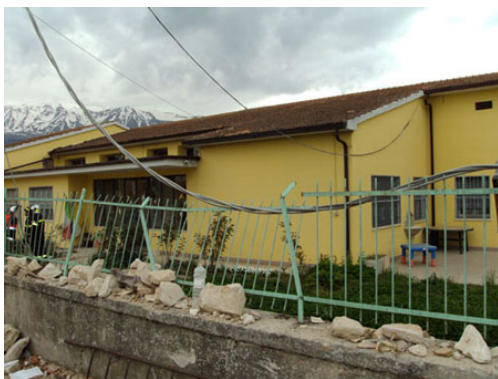
Notably, a recently-built school in Onna performed extremely well, with no apparent damage to the exterior (Figure 14). It took the collapse of a school in the Molise earthquake in 2002, which resulted in 26 of the 28 fatalities from that earthquake, to prompt the imposition of much stricter codes in the construction of schools in Italy. The school in Onna provided proof of the efficacy of the new code.

Figure 14. Newly built school in Onna with no evident damage; structures on the opposite side of the street suffered partial or complete collapse. Source: AIR

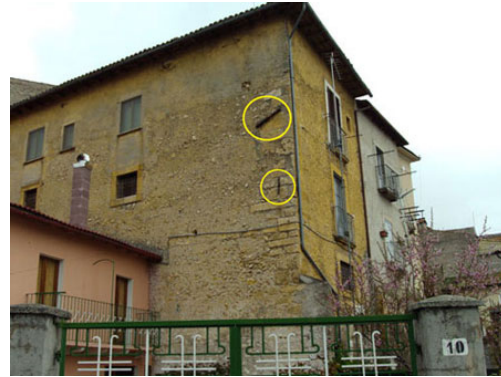
At Barisciano, the town furthest from L'Aquila that was surveyed, the proportion of masonry structures that partially or completely collapsed was significantly lower than that observed in Onna. Even the most vulnerable construction types, such as the mixed masonry building shown in Figure 15 showed slight or no damage.

Figure 15. Three-story mixed masonry building reinforced with cross-ties in Barisciano appears to be intact. Source: AIR

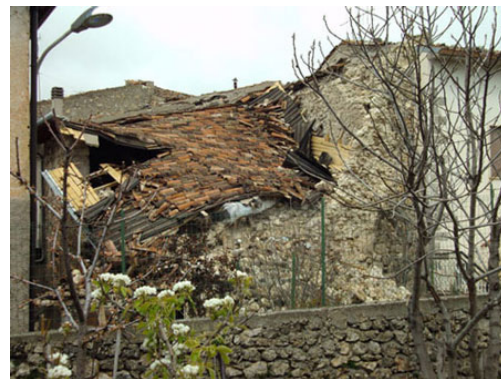
There were exceptions, however. Figure 16 shows the almost total collapse of an old two-story unreinforced masonry structure, also in Barisciano.

Figure 16. Collapse of a two-story masonry house in Barisciano; the corner of the two-story structure at the far left is shown again in Figure 6. Source: AIR

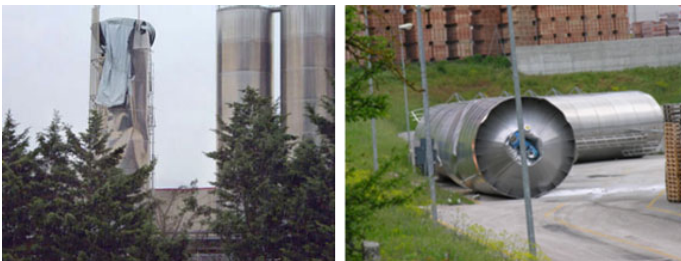
Industrial facilities in the region, which are dominated by RC construction, generally sustained little or no structural damage, but a moderate degree of cracking of infill walls. Figure 17 shows the partial or complete collapse of steel silos.

Figure 17. Complete collapse of two steel silos (located where the empty spaces are) containing polypropylene beads and partial collapse of a third. Parts of the collapsed silos were being stored in the yard to be salvaged and reused. Source: AIR

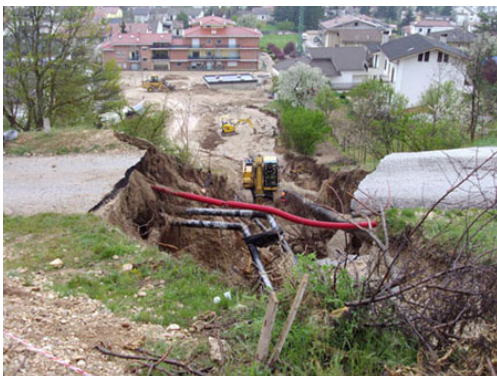
Damage to infrastructure included the collapse of a 0.9 m (2.9 feet) diameter high-pressure water supply pipeline near the town of Paganica. The rupture triggered a landslide and subsequent mud flow (Figure 18), although none of the nearby residential structures was affected.

Figure 18. Landslide caused by the rupture of a water supply pipe. Source: AIR

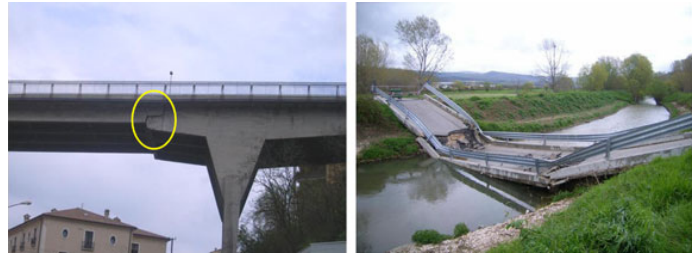
Cracks were observed on the piling of a 30 m (98 ft) long masonry bridge located at the southwest edge of L'Aquila (not shown). Another short bridge near the town of Fossa completely collapsed (photo on the right in Figure 19), while a large reinforced concrete bridge in L'Aquila was closed due to the displacement of one of its beams on the supporting pier (left in Figure 19).

Figure 19. Damage to bridges in and around L'Aquila. Source: AIR

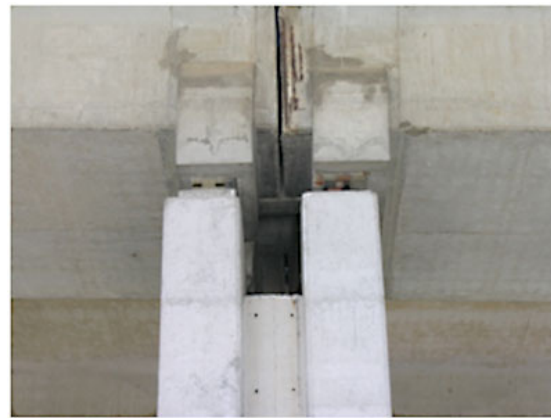
Many spans of the viaduct of the highway A24 in L'Aquila were lifted off from the bearing pads on top of the piers resulting in a misalignment. The part of the highway was still closed to traffic when the team surveyed the area.

Figure 20. Spans of L'Aquila's viaduct were lifted off and misaligned with supporting piers. Source: Paolo Clemente (EERI team)

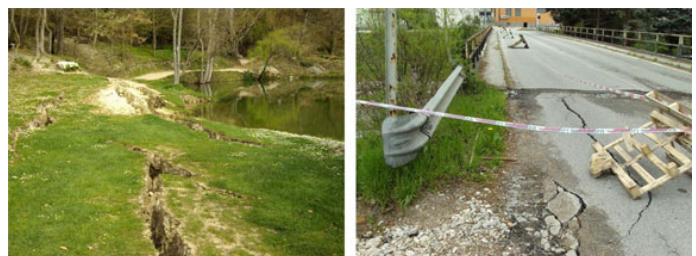
Ground failure was also observed, in some cases resulting in damage and closure of local roadways.

Figure 21. Instances of ground failure in and around L'Aquila. Source: AIR
