POST-DISASTER SURVEY FINDINGS FROM THE M8.8 CHILE EARTHQUAKE

04.2010

By Dr. Guillermo Franco, Guillermo Leiva and Dr. Tao Lai

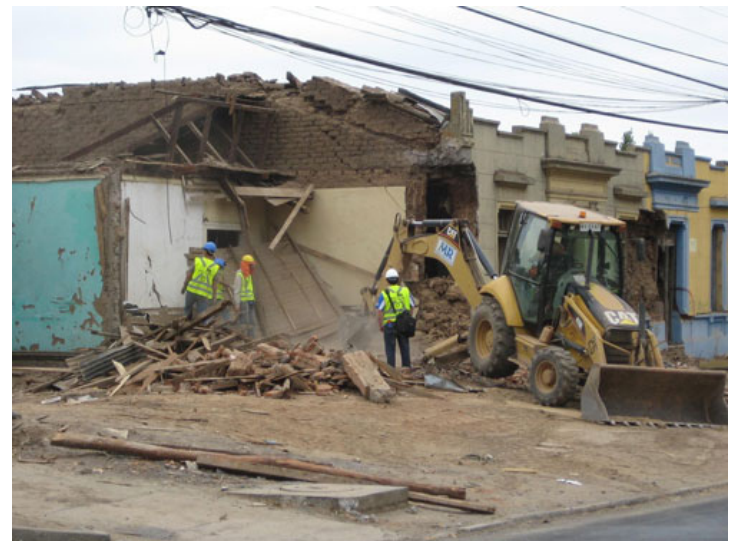
Talca, the capital of the Maule Region, and some 115 km from the epicenter, was one of the towns hardest hit. Its historical center, which consisted predominantly of adobe, was devastated. Approximately 1,500 adobe homes in Talca were either destroyed or were undergoing demolition at the time of AIR's survey. The municipality has not yet fully defined a plan for reconstruction, to the consternation of residents.

Figure 4. Demolition crews have begun their work in Talca. (Source: AIR).

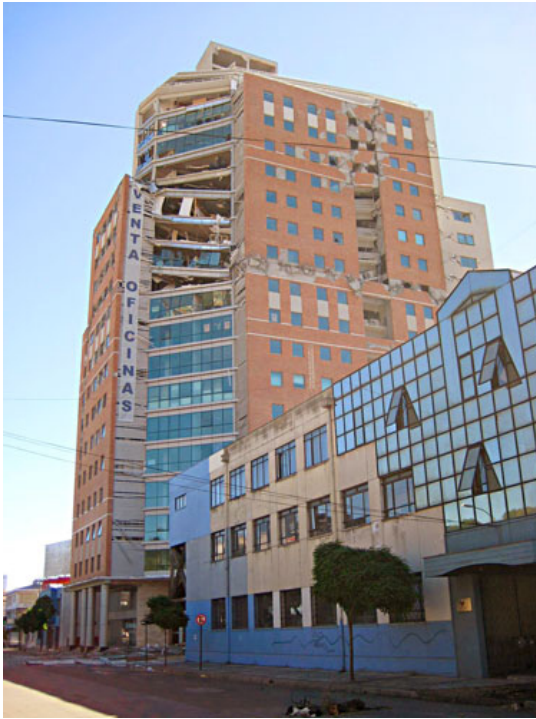
One building in Concepción scheduled for demolition is the Torre O'Higgins building, a reinforced concrete high-rise of 21 stories. Figure 5 shows the multiple shear failures along its height, as well as the failure of what appears to be a dual system of frames and shear walls. This building has vertical irregularities that may have been responsible for its poor performance. Preliminary observations by various structural engineering teams, including AIR's survey team, conclude that these irregularities are likely to have increased the torsion of the building under earthquake loads, which led to severe damage.

Figure 5. The Torre O'Higgins high-rise suffered severe damage and is scheduled for demolition. (Source: AIR).

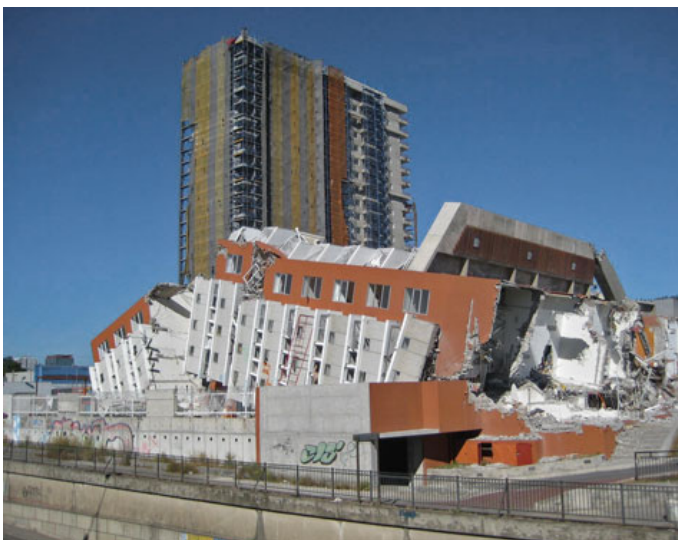
The only fully collapsed modern building in Chile—a multi-story reinforced concrete residential structure—was on Avenida Arturo Prat in Concepción (Figure 6). The building crumbled a few minutes after the earthquake struck, killing eleven people. Initial observations into what caused the collapse indicate insufficient reinforcement, vertical discontinuity of shear walls, and possibly poor material quality.

Figure 6. The only fully collapsed modern building was located in Concepción. (Source: AIR).

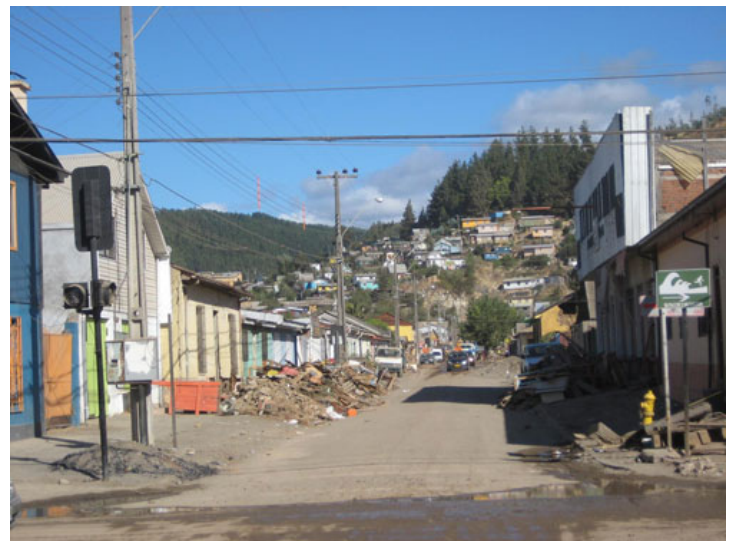
Figure 7 shows a section of the city in the quadrant defined by Hospital, Oñederra, Rengifo, and Echeverría streets. Most of the buildings on the plain will have to be demolished. Tourism in this seaside town has been brought to a halt, leaving even undamaged apartment buildings empty. Fisheries and industry in the town have also been paralyzed.

Figure 7. Constitución is on a plain surrounded by hills. While the hills were not greatly affected by the earthquake, structures on the plain were heavily damaged due to shaking and tsunami. (Source: AIR)

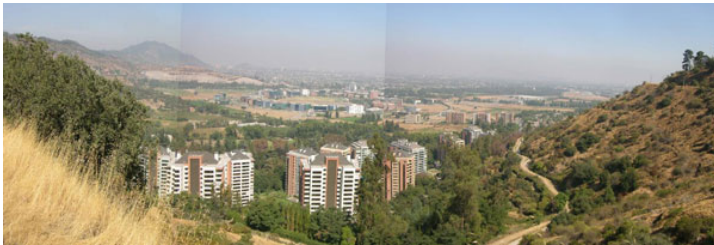
Figure 8. Panoramic view of La Ciudad Empresarial, Huechuraba, Chile (Source: AIR)

AIR's team preliminarily concluded that damage in this area might have been exacerbated by soft soils, probably highly saturated with water, that characterize the basin (Figure 8). The area had been a combination of wetlands and farmland until construction on the park began about twenty years ago. The incoming seismic waves from the February 27 event were likely trapped by the basin and amplified by the soft alluvial soils, which in turn intensified damage to structures. Note that the buildings in the foreground of Figure 8 suffered no damage at all since they were sitting on stiffer ground on hills at the basin's edge. Figure 9 shows further instances of ground failure at La Ciudad Empresarial.

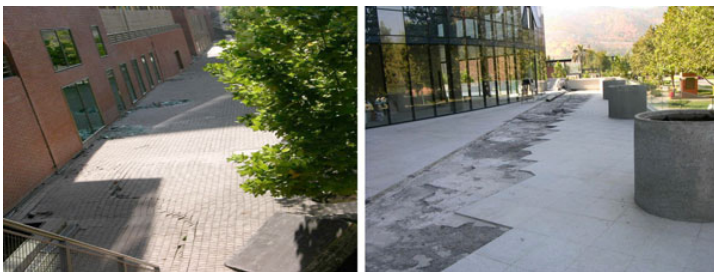
Figure 9. Settlement (left) was observed outside buildings in La Ciudad Empresarial. Cracks (right) propagated along the ground due to soil settlement. (Source: AIR).

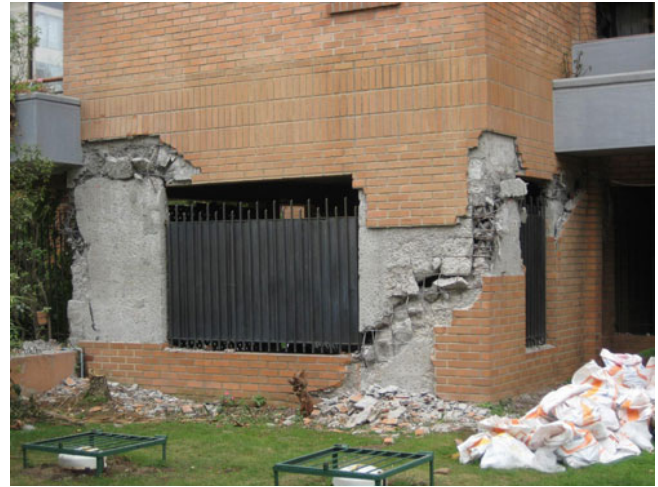
Chile's construction largely relies on shear wall engineering. Much of it performed well, but there were exceptions. In the coastal city of Viña del Mar, just north of Valparaiso, AIR engineers entered the building pictured below, which had suffered a partial collapse of a concrete shear wall. Two of the building's structural walls failed, causing a 10 centimeter vertical displacement. The whole wall segment pictured in Figure 10 exhibited severe tilt.

Figure 10. Partial collapse of high-rise apartment building in Viña del Mar. (Source: AIR)

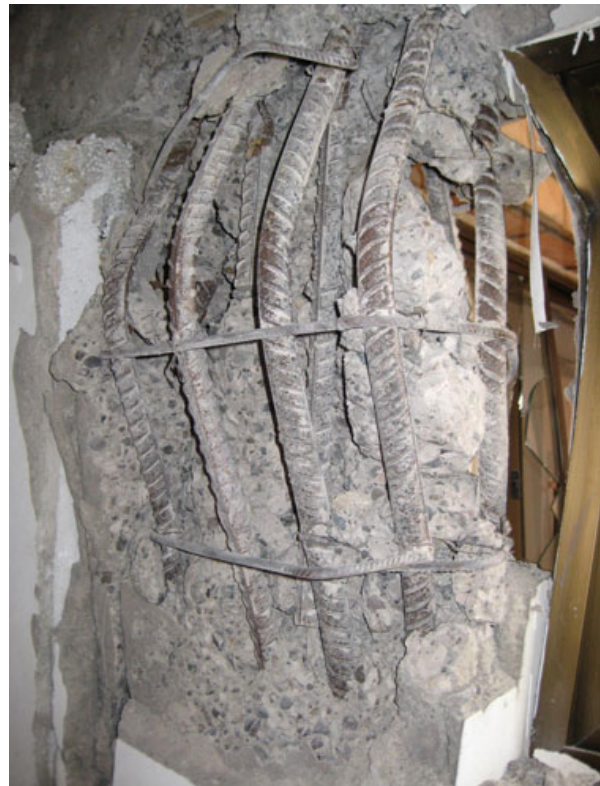
Inside the building, the team noticed severe cracking in the walls of an apartment unit they examined, as well as deformation of the slab and cracking of the stairwell. Figure 11 shows the interior side of one of the building's structural walls; compression due to the effect of gravity loads compounded by the bending of the structural system might have caused the failure of this wall section and the subsequent buckling of the longitudinal rebar.

Figure 11. Buckled longitudinal rebar in structural wall of Viña del Mar building (Source: AIR).

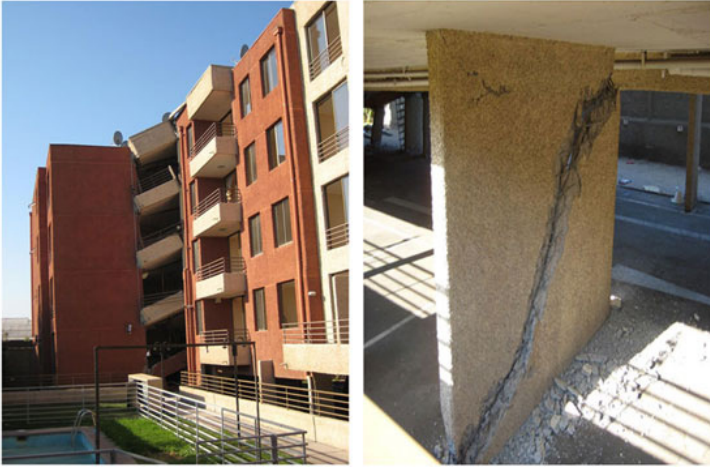
In Maipú, a municipality south-west of downtown Santiago, AIR's team visited a building that was partially collapsed due to shear wall failure; it will have to be demolished (Figure 12, right). The building appeared to have suffered excessive lateral displacement and, as a result, it lost support from the load bearing walls in one of its corners (Figure 12, left).

Figure 12. Partially collapsed building in Maipú, greater Santiago. (Source: AIR)

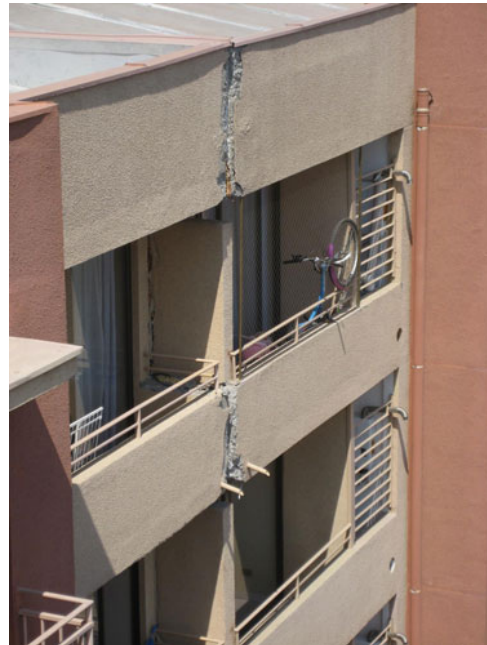
Pounding is the technical term for the collision of adjacent buildings during an earthquake due to insufficient lateral clearance or to a poorly designed construction joint. This type of effect was observed in one apartment building in Independencia, which consisted of two L-shaped structures symmetrically arranged and built within a year of each other. The construction joint was not adequately designed to provide enough separation to prevent pounding and, as a result, cracks were evident at the location of the joint (Figure 13).

Figure 13. Evidence of pounding between the original structure and a later addition. The construction joint did not provide enough separation to prevent pounding. (Source: AIR)

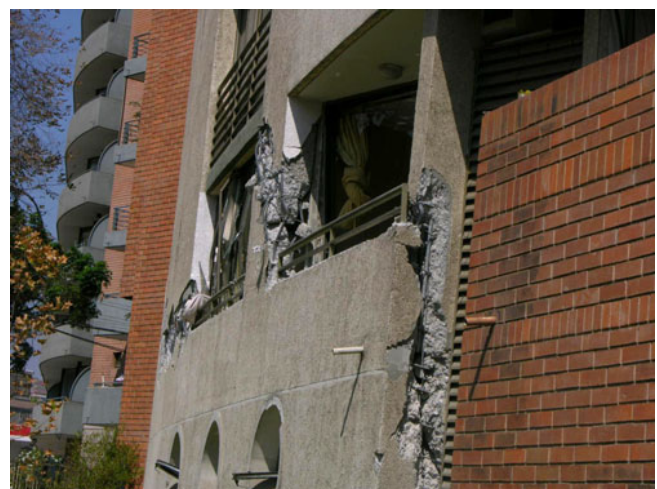
The wall structures of the Central Park building on Balmaceda Street in Santiago experienced dramatic failures. Local residents reported that the major lateral shaking from the earthquake took place in the direction perpendicular to the façade (Figure 14), which is the weakest direction of the building in terms of overall resistance.

A neighboring building (in the far left background)—apparently with similar structural characteristics but rotated by 90 degrees—showed no damage. This suggests that the strongest lateral motion took place coincident with the first building's weakest direction and the second building's strongest direction. These buildings provided a clear illustration of how the orientation of a building with respect to the ground motion it experiences can affect its performance.

Figure 14. Failure of structural wall, Central Park building. (Source: AIR)
