IN THE AFTERMATH OF CYCLONE YASI: AIR DAMAGE SURVEY OBSERVATIONS

03.2011

By Dr. Kyle Butler and Dr. Vineet Jain
Edited by Virginia Foley

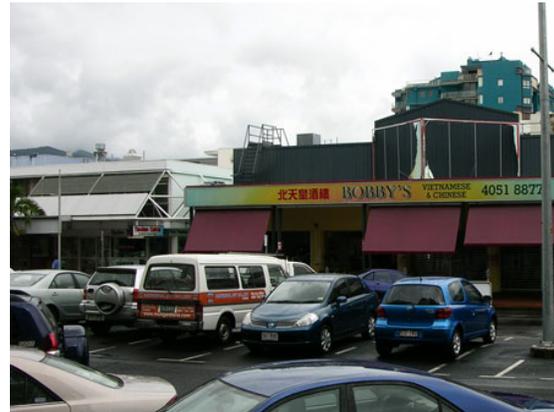
Apartment buildings within the Cairns central business district, which are generally of newer high-rise reinforced concrete construction with significant glass exposure, escaped unharmed. Damage to commercial construction, which generally consists of one- to two-story masonry or steel framed structures with flat or metal roofing, was minimal and was largely restricted to signage or cladding on the canopies above pedestrian sidewalks (Figure 3).

Figure 3. Damage to signage along a shopping plaza in Cairns (Source: AIR)

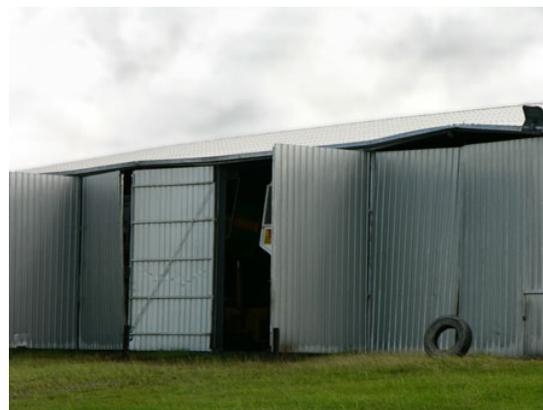
Tully and Mission Beach bore the brunt of Cyclone Yasi's powerful winds, and access to the worst affected areas was still restricted when the survey team arrived. They did, however, observe significant structural damage to many buildings along the perimeter of the restricted area. Damage to farm structures—mainly light metal storage buildings—was widespread. Figure 4 shows the deformation of the frame around the doorway and the door of a light metal shed. Typically, doors of light metal construction can be forced open by wind pressure or the impact of flying debris, with subsequent damage leading to more significant failures of the overall structure.

Figure 4. Metal sheds suffered deformation to doors and frames. (Source: AIR)

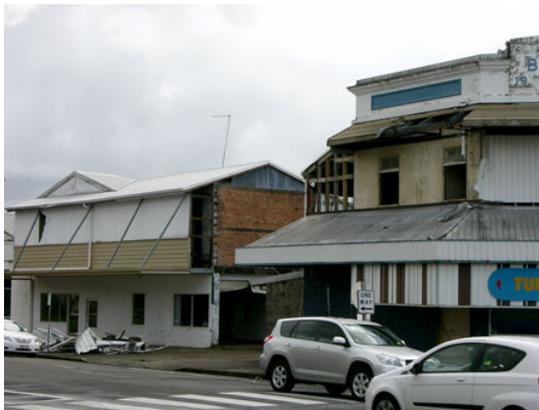
In downtown Tully, the majority of commercial construction is comprised of one-to three story buildings from the 1920s and 1930s, which are composed of a mix of wood, brick and masonry construction with sheet metal roofs. Figure 5 shows various degrees of cladding damage. While the wind speeds were certainly a factor, the team observed some inadequate fastenings and anchorage where the siding had been ripped off. Given the age of the structures in the area, deterioration of fasteners and connections may have hastened the failure of roofing and cladding components.

Figure 5. Buildings in downtown Tully with damage to exterior surfaces, exposing the frame systems beneath. (Source: AIR)

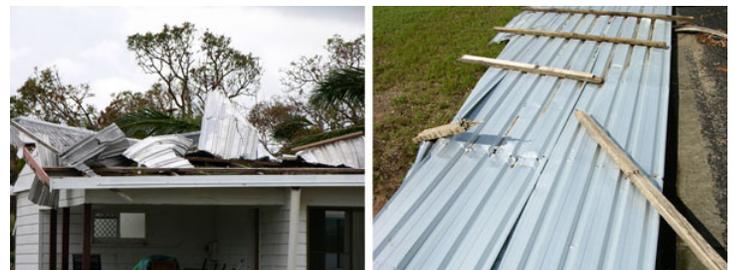
Cardwell consists mainly of residential structures, which are dominated by wood-frame buildings with metal roofing. Commercial construction here consists primarily of masonry also with metal roofs, as well as a mixture of metal and wood canopies located above the pedestrian sidewalks. The most noticeable residential damage occurred to roofing, where the team discovered that failure of cladding fasteners (or roof tie-downs) contributed to much of the visible structural damage. In some cases, the team observed failed metal roof sheeting, with battens attached, and pull-out of nails (Figure 6), which did not provide the needed resistance to uplift from the cyclone.

Figure 6. (left) Failure of metal roofing panels at the bolted connections; (right) Failed roofing panel showing nails which would have connected the roofing battens to the frame. (Source: AIR)

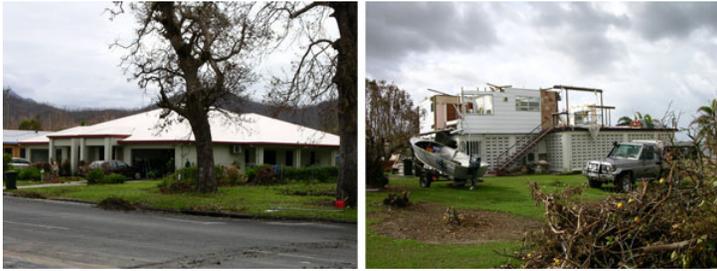
Prior to 1975, a common component of cyclone-resistant construction was the retrofit of buildings with so-called “cyclone bolts,” connectors that extend from the top to the bottom of a wall for the purpose of tying down the roof. At the time, there was no design requirement for these bolts, and placement was left to the discretion of the builder. The effectiveness of cyclone bolts came into question during Cyclone Tracy and, around the same time, the government embarked on an initiative to standardize the wind loading code for the country. Nevertheless, the team observed instances in which the use of cyclone bolts, as indicated by the building owners, provided little or no effective roof uplift resistance or wall panel support (right panel of Figure 7).

Figure 7. (left) Newly constructed home with no damage; (right) older home, retrofitted with cyclone bolts, sustained significant damage. (Source: AIR)

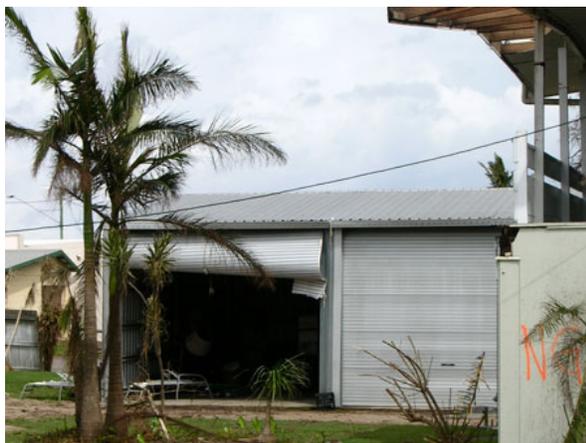
Preliminary observations by various structural engineering teams, including AIR’s, noted that overhead roller doors did not perform well under Yasi’s wind loads. During Cyclone Larry in 2006, there was a high incidence of roller door failure and it had been well recognized at that time that roller doors did not adequately satisfy the wind load requirements of the building code. The door pictured in Figure 8 failed as a result of wind lock mechanisms or failure of the attachment to the door frame. While roof damage was not observed in this case, this type of failure can pressurize the building, leading to failure of the roofing system.

Figure 8. Failure of overhead roller door—a repeat of damage patterns seen in 2006 from Cyclone Larry. (Source: AIR)

the design criteria of roller doors. Recently, there has also been discussion to extend the parameter of the high-wind zone further inland. However, damage to older houses, particularly ones built before 1975, suggests that there have been challenges to bringing older homes into compliance with current building codes.

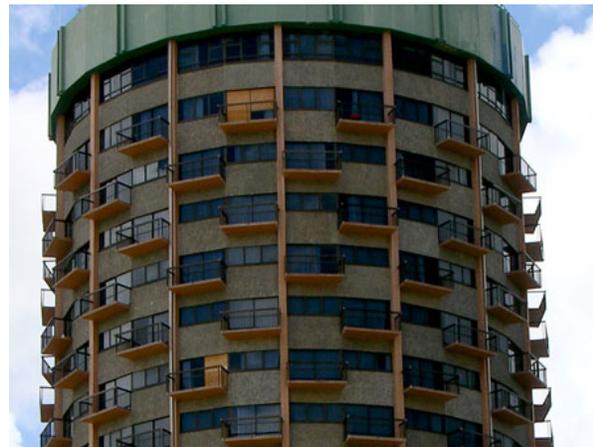
Considered the unofficial capital of North Queensland, Townsville is a large metropolitan area with a growing tourist population. As such, the dominant commercial construction along the coastal areas and marina consists of high-rise hotels and apartments composed of reinforced concrete and masonry. Figure 9 shows minimal window damage to the Holiday Inn, dubbed the “Sugar Shaker” by local residents. As would be expected in well-engineered steel and reinforced concrete structures, damage was limited to non-structural components.

Figure 9. Plywood covering window damage at the Holiday Inn in Townsville. (Source: AIR)
