# THE 1976 FRIULI, ITALY, EARTHQUAKE

05.2011

EDITOR'S NOTE: Editor's Note: This month marks the 35th Anniversary of a magnitude 6.4 earthquake that occurred in the Friuli region of northeast Italy. AIR director of engineering analysis and research Dr. Paolo Bazzurro describes what happened that day, its aftermath, and its lasting effects.

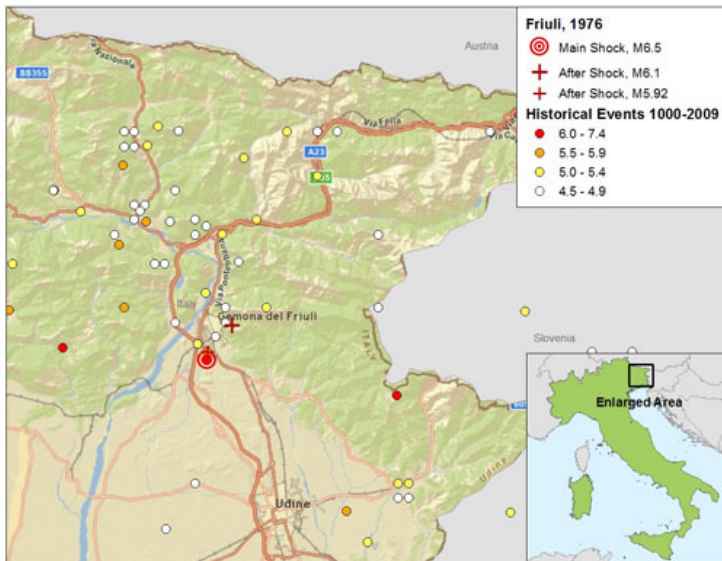
Figure 1. The Friuli region of northeastern Italy showing the 1976 mains shock and strongest aftershocks, along with historical seismicity (Source: AIR)

Italy's Friuli region rolls down the lower slopes and foothills of the eastern European Alps into the flat flood plain of the River Tagliamento. To the east, today, is Slovenia, to the north, Austria. For centuries the foothills have been home to vineyards and small towns that in the 1960s had begun to make a transition from mostly farming to small-factory manufacturing. The historical capital of the region, Udine, lies to the south in the fertile Friuli plain (see Figure 1).

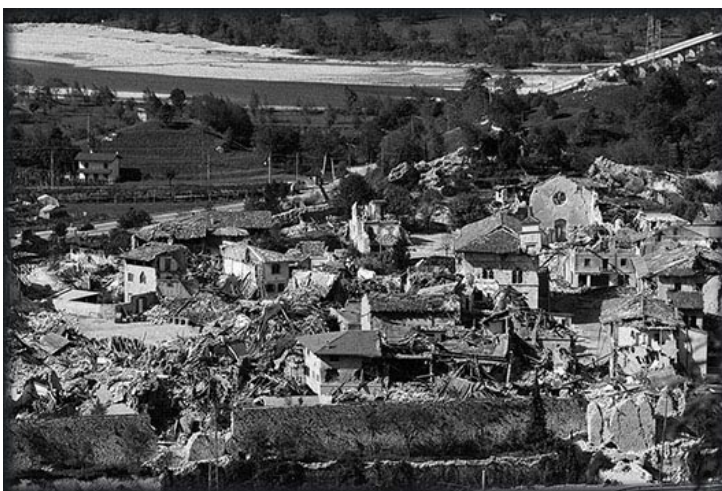
Figure 2. The Town of Venzone after the Earthquake (Source: Associazione Comuni Terremotati e Sindaci della Ricostruzione del Friuli)
