2017 Hurricane Irma and 2018 Hurricane Michael Provided Unique Learning Opportunities

Modeling Fundamentals: Why Does AIR Conduct Post-Event Damage Surveys?

Collateral wind damage to properties in Florida – 2017 Hurricane Irma & 2018 Hurricane Michael

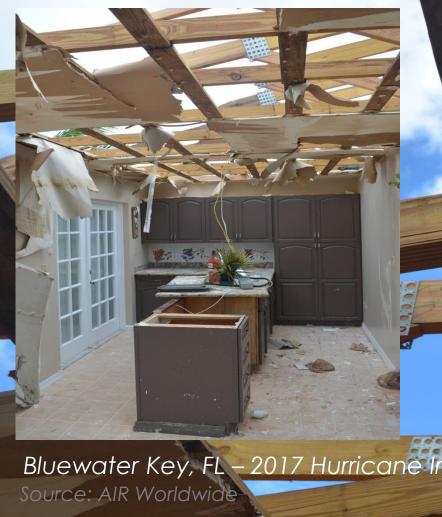
Bluewater Key, FL - 2017 Hurricane Irma

Roof sheathing failure due to inadequate connections to the underlying framing

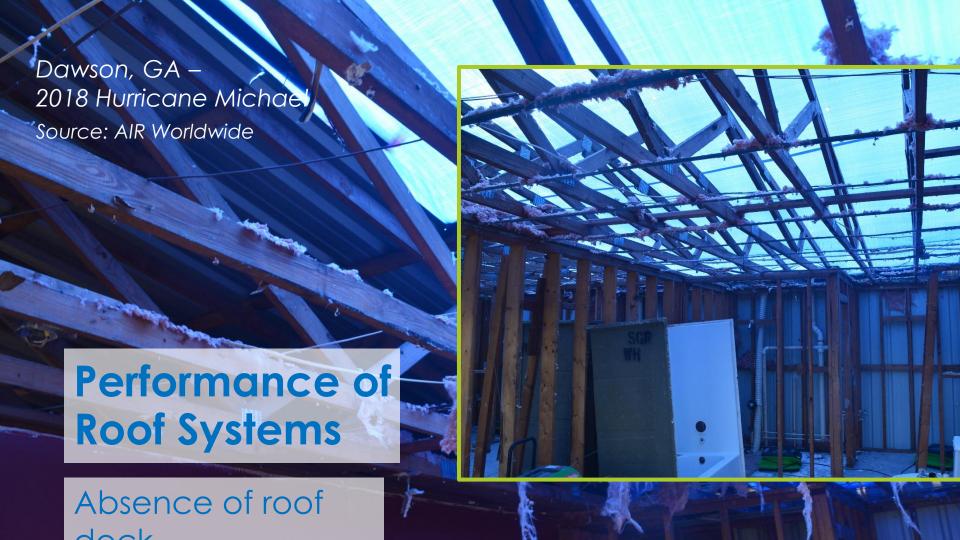
Performance of Roof **Systems**

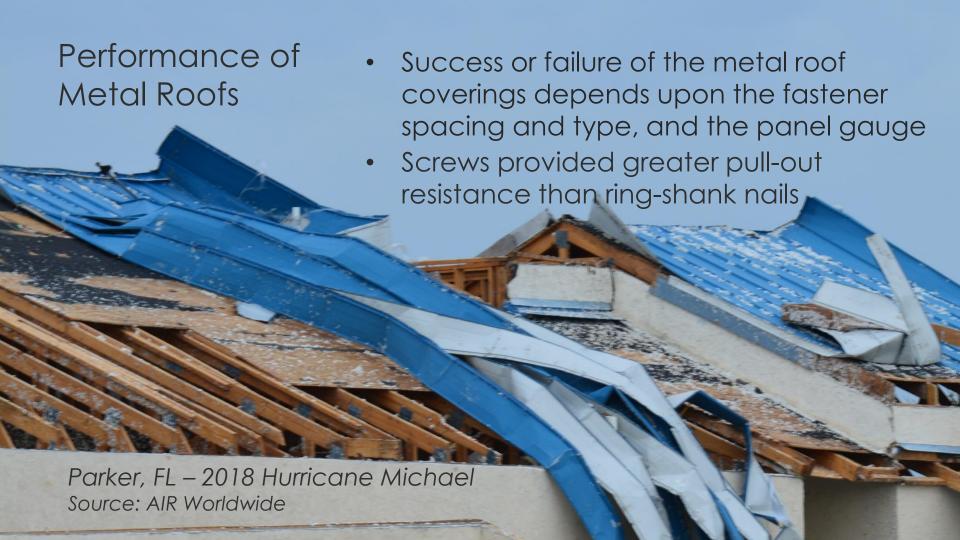
Marathon, Florida – 2017 Hurricane Irma

- Metal panel roofs performed better than asphalt shingles or tiled roofs
- Significant damage was seen to roofs with shingles and clay/concrete tiles

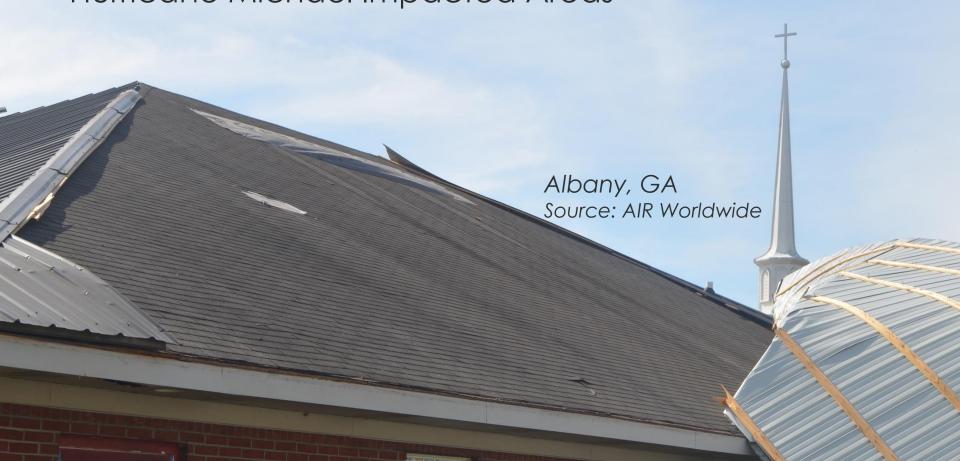
Relatively Poor Performance of Metal Roofs in Hurricane Michael Impacted Areas

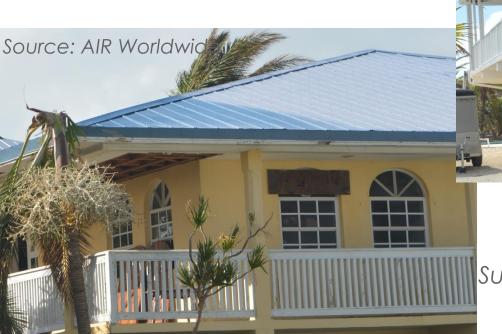
Lower Sugarloaf Key, Florida – 2017 Hurricane Irma

Damage to soffits was most common in metal panel roofs

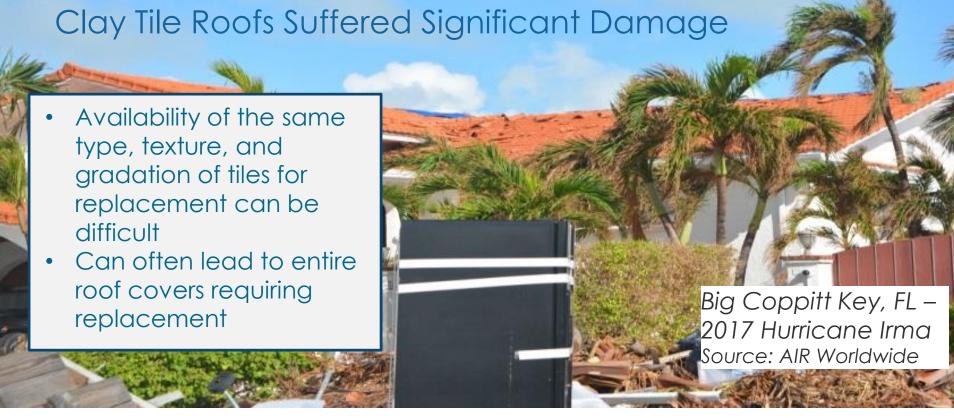
Summerland Key, Florida

Mortar and adhesive-set clay tiles suffered the most damage in comparison to mechanically attached ones

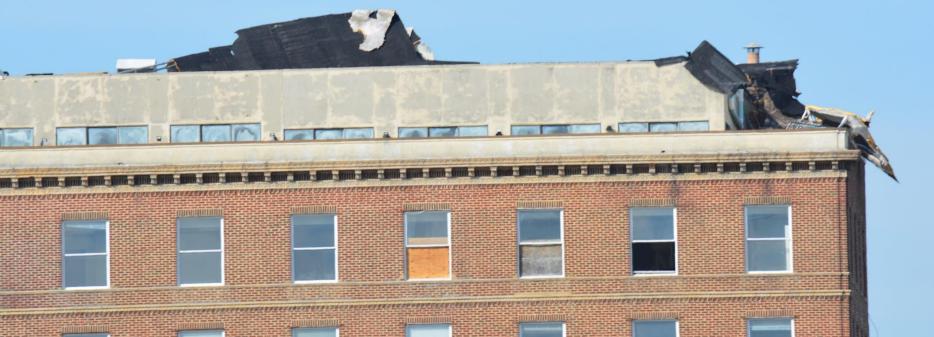
Albany, GA – 2018 Hurricane Michael Source: AIR Worldwide

Significant Damage to Commercial Built-Up Roofs

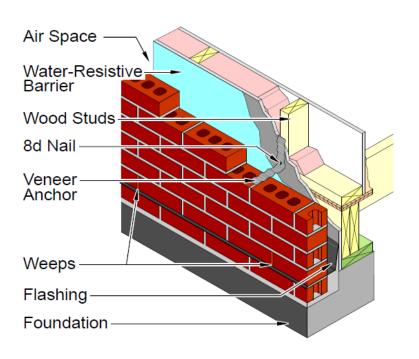
Source: The Brick Industry Association

Brick Veneer – Wooden Stud Wall System

- Space anchors no more than 18" vertically (as per IBC)
- Space additional anchors within 12" of openings larger than 16" at a maximum spacing of 3 feet
- Secure anchors to the studs through the sheathing and not to the sheathing alone

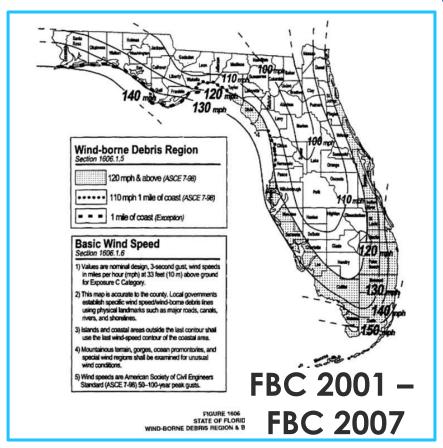
What defines the Wind-Borne Debris Region (WBDR)?

- Areas with design wind speed ≥120 mph
- Areas with design wind speed ≥110 mph and within 1 mile of the coastline

FBC 2001 made a political decision to exclude large swaths of the Panhandle from WBDR. Although that was reversed in FBC 2004, FBC 2010 and later significantly reduced the WBDR in this region.

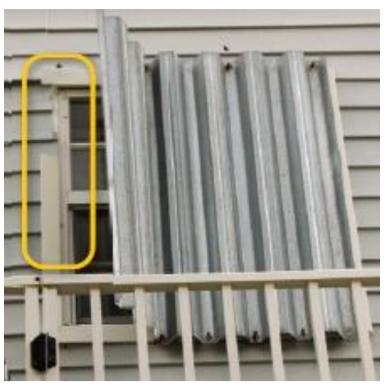
Goodland, FL – 2017 Hurricane Irma

- Variability in the level of opening protection in Monroe County
- Improper installation of shutters

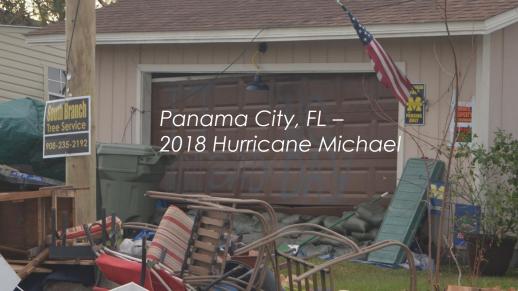
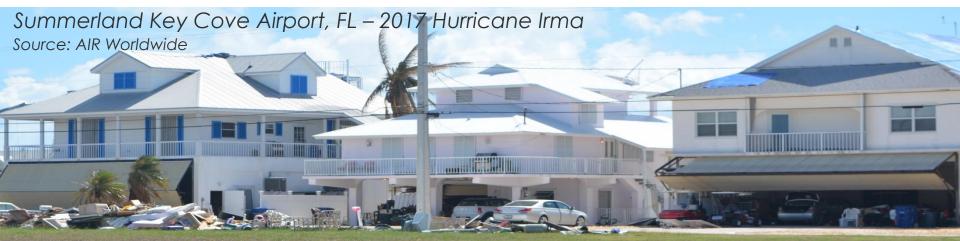
Garage Door Failures

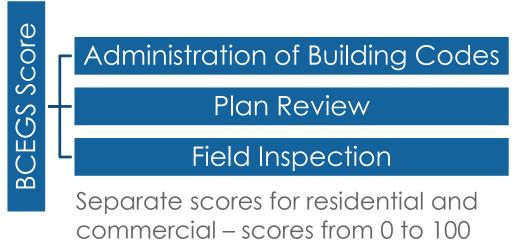
Through the BCEGS program, ISO® assesses the building codes in effect in individual communities and how these communities enforce their building codes

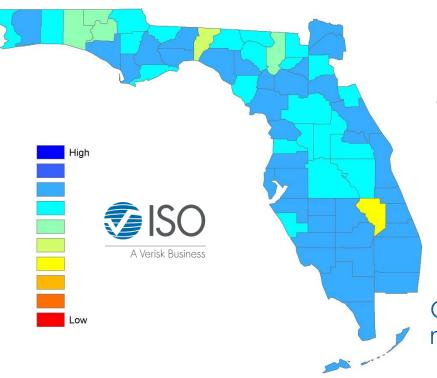
County-level variation in residential BCEGS score in Florida

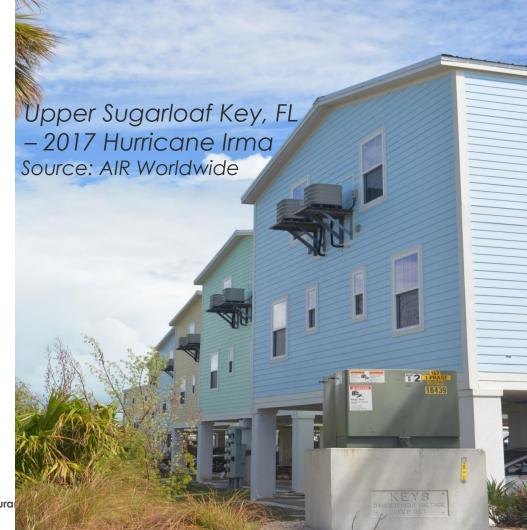
Building Codes Can Minimize Surge Damage

- First floor elevated sufficiently above ground
- Elevation of service equipment

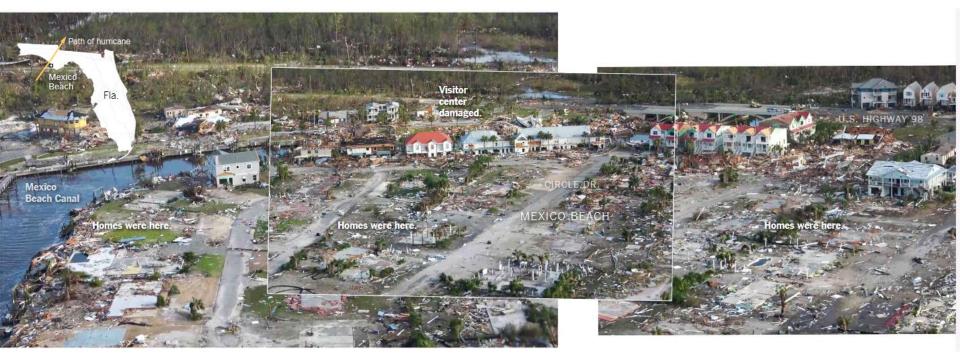
Source: The New York Times, Hurricane Michael: One Mile of Devastation in Florida

Storm Surge Devastation in Mexico Beach, FL

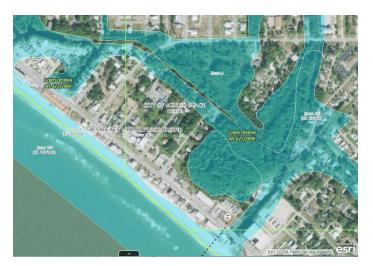
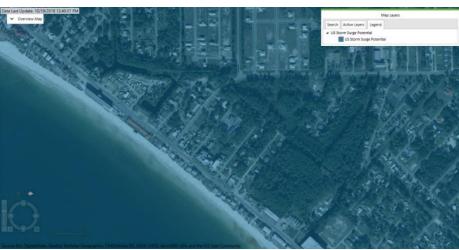
Storm Surge Potential for Mexico Beach Source: AIR Hurricane Model for the U.S.

How Did the FEMA Flood Maps Fare in Areas Worst Affected by Michael's Storm Surge?

The extent of storm surge went well beyond FEMA designated V, A zones and into the X zones (areas of minimal flood hazard)
