OBSERVATIONS FROM THE MAGNITUDE 6.3 L'AQUILA EARTHQUAKE

05.2009

By Drs. Paolo Bazzuro, Guillermo Franco and John Alarcon

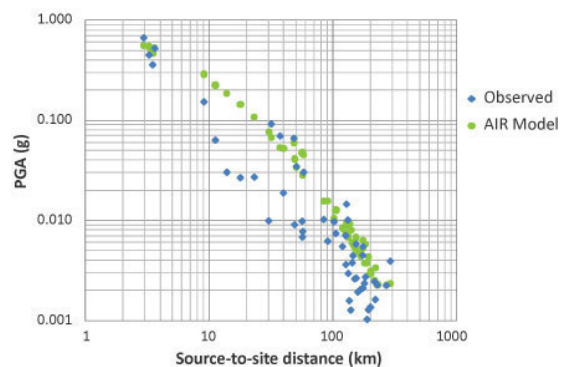
Figure 2 shows a comparison between ground motion observations published by Italy's Office of Civil Protection and ground motion for the event as estimated by AIR's Italy earthquake model. Near-source recordings can be rare, but are critically important for purposes of damage and loss estimation.

Figure 2. Comparison between AIR Modeled Mean Ground Motions and Observed Ground Motions

It is worth noting that one of the instruments in the epicentral region recorded peak ground acceleration (PGA) of 0.67g.¹ Yet until 2003, buildings in L'Aquila and its province were considered to be in a moderate "Class 2" seismic zone, which prescribes only that buildings be able to withstand a peak horizontal acceleration of 0.23g. The newer building code released in 2003 and revised in 2008 require design PGA of 0.25g. In either case, given the observed ground motions, the implications for the levels of damage the survey teams would see were clear.

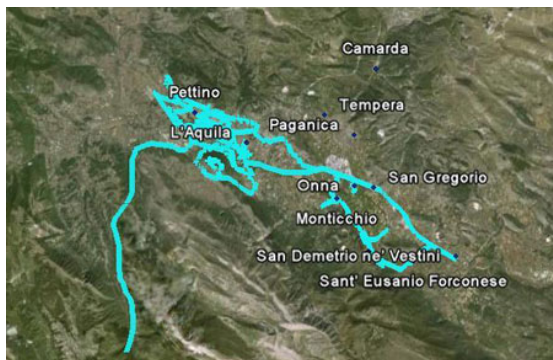
AIR engineers spent one week traveling throughout the affected region, collecting and synthesizing information on structural and non-structural damage. Their routes are shown in Figure 3. Most of the towns visited lay along the valley formed by the Aterno River, though forays were also made into the more mountainous terrain to the west and nearer the epicenter.

Figure 3. Blue outline represents the area visited by the survey teams.
