IN THE AFTERMATH OF CYCLONE YASI: AIR DAMAGE SURVEY OBSERVATIONS

03.2011

By Dr. Kyle Butler and Dr. Vineet Jain
Edited by Virginia Foley

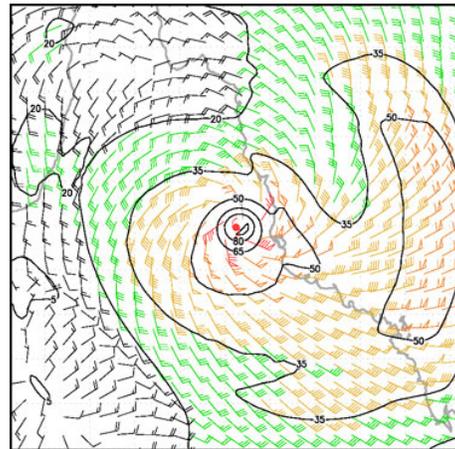
By the next day, it became clear that Yasi would spare central Queensland, which had been devastated by heavy flooding in December. But there was little else in the way of good news. Yasi made landfall on the northeast coast of Queensland on February 3 between Innisfail and Cardwell with recorded gusts of 185 km/h. Satellite-derived sustained wind speeds of 200 km/h were estimated near the center (Figure 1), indicating that gusts over 250 km/h had likely occurred.

Figure 1. Satellite-derived 10-minute sustained wind speeds in knots just after Cyclone Yasi made landfall. Maximum winds to the left of center translate to 1-minute sustained winds of 200 km/hr. Source: NOAA-NESDIS-RAMMB
