WINTER STORM KLAUS: FINDINGS FROM THE AIR DAMAGE SURVEY

02.2009

By Alexandra Fisher, Tom Hughes and Dr. Vineet Jain

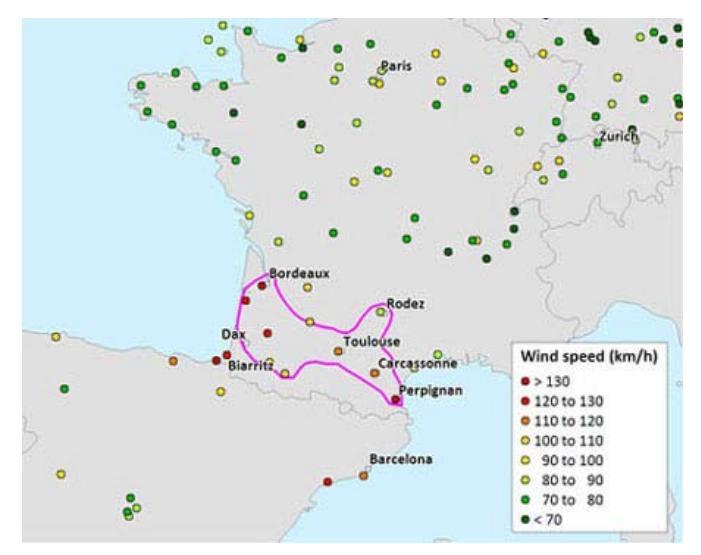
Two days after the passage of Klaus, AIR dispatched postdisaster survey teams to affected areas of France to assess the damage. Figure 2 shows Klaus' maximum recorded wind speeds, as well as the region surveyed by AIR (outlined in pink).

Figure 2. METAR data for winter storm Klaus. Pink outline represents the area visited by AIR's post-disaster survey teams

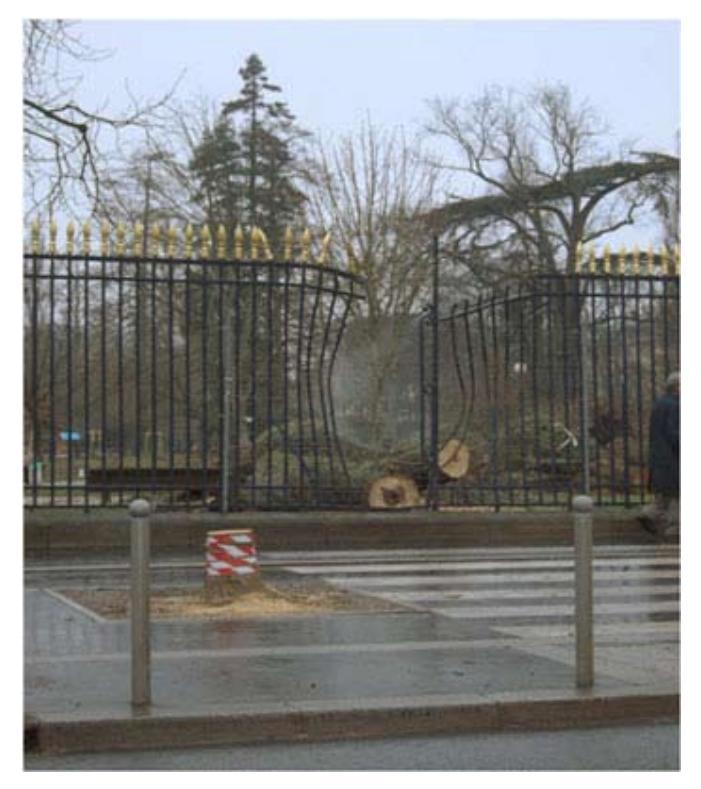
This area experienced some of the highest wind speeds within the storm's footprint, which was consistent with damage observations. However, in the well-maintained city center of Bordeaux, damage was minimal and largely restricted to that caused by uprooted trees falling on nearby structures (Figure 3).

Figure 3. Fence damage at the Jardin Public in Bordeaux (Source: AIR)

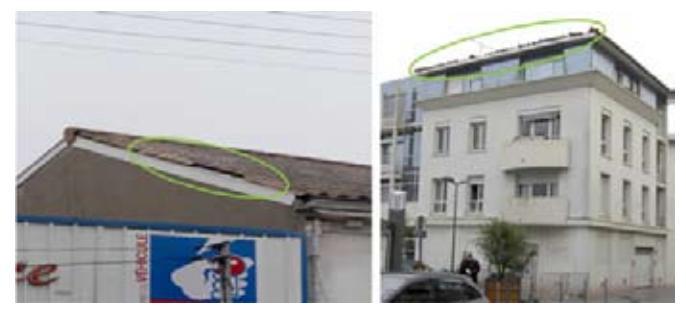
In the residential areas surrounding Bordeaux, wind damage was more widespread, though still observed in less than 5% to 10% of buildings. Damage was generally restricted to minor roof tile damage and occasional chimney damage. The dominant residential construction in this area is one- to two-story detached masonry houses and taller three- to four-story apartment blocks of reinforced concrete. The damage to roof tiles on the latter was more significant because of the higher profile of such buildings (wind speeds increase with height). However, no structural damage was observed to either construction type.

Figure 4. Roof tile damage to low-rise masonry construction in Avenue de la Republic (left) and to four-story reinforced concrete construction in Pessac (right) (Source: AIR)

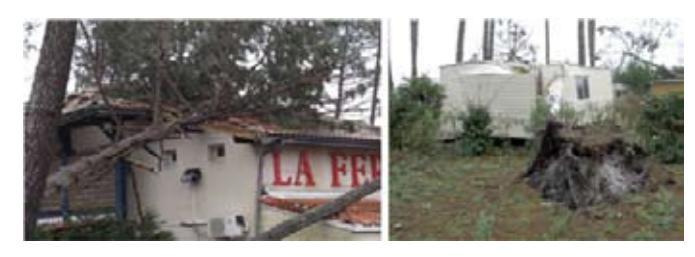
Beginning about 65 km southwest of Bordeaux, tree damage became more common. In the coastal towns of Gujan-Mestras and Saguinet (Figure 5), the team observed many instances of trees that had fallen on properties, causing significant structural damage. At the campsite "les Grandes Pins" in Saguinet, an estimated 150 caravans (mobile homes) were destroyed by downed trees. Significantly—and with implications for actual wind speeds on the ground—few trees appeared to have been snapped by high winds; instead, they had been uprooted due to the combination of wind and heavily saturated soils.

Figure 5. Damage caused by fallen trees in Gujan-Mestras (left) and Saguinet (right) (Source: AIR)

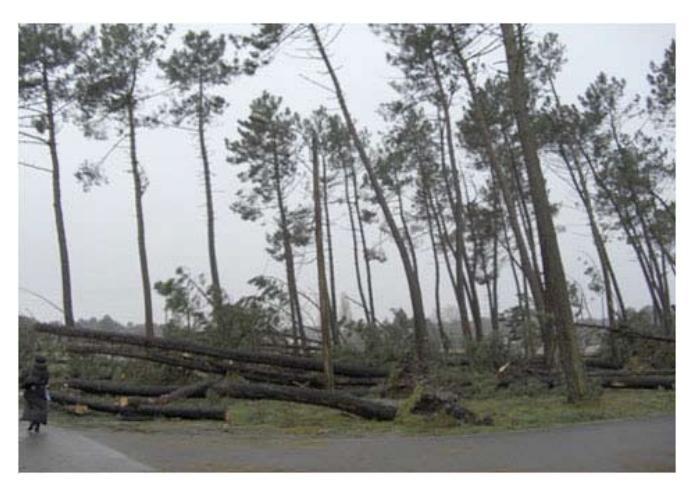
Figure 7. Toppled forests (left) and utility workers repairing power lines (right) in the Landes region (Source: AIR)

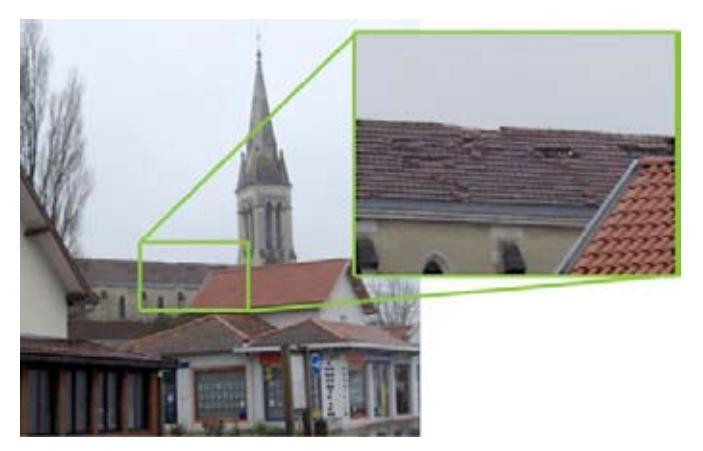
Throughout this region, the team observed a consistently higher incidence of damage to older buildings than to newer ones. Churches, often the oldest and tallest structures in town, and vulnerable to dynamic wind loads because of their slender structures, were particularly hard hit (Figure 6). South and inland from the Bordeaux area, the team traveled through Landes, where Klaus is reported to have downed over 60% of the trees in Europe's largest maritime forest. The forests, mostly privately owned, account for about a third of France's lumber production. Forestry officials estimate that 50 million cubic meters of timber was toppled by Klaus. According to the French Private Forestry Federation, only 5% of privately owned forests are covered by property insurance, which includes windstorm coverage. Nevertheless, commercial forestry damage remains a significant source of uncertainty with respect to ultimate insured losses.

Figure 6. Churches across the region sustained significant damage to roof tiles (Source: AIR) $% \left({{\rm Source}} \right)$

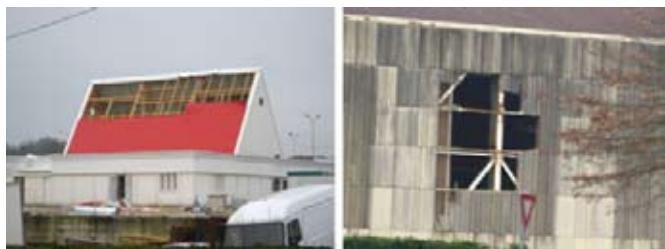
Further south toward Dax, the team continued to observe a high incidence of uprooted trees and even trees sheared off. The first significant damage to commercial structures was seen in Dax, where sheet metal roofs or siding had been peeled off (see Figure 8).

Figure 8. Roof and siding damage to low-rise light metal commercial buildings in Dax (Source: AIR) $% \left(S_{\mathrm{A}}^{\mathrm{A}}\right) =0$

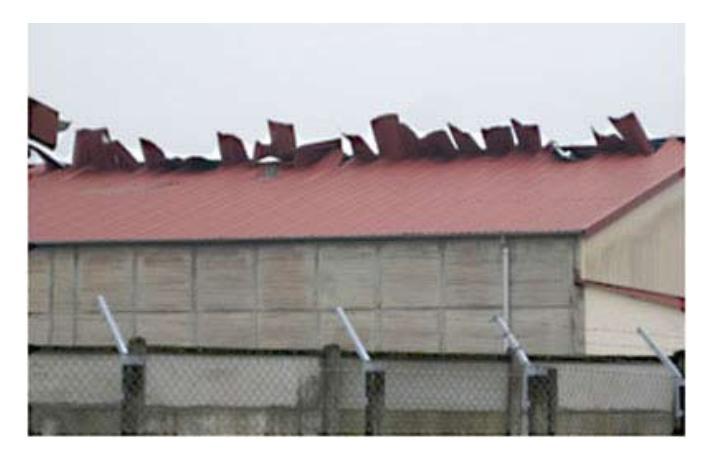
Light metal construction with large spans can be highly vulnerable even at a low to moderate wind speeds. One hangar of the Dax Helicopter Museum suffered significant roof damage (see Figure 9).

Figure 9. One out of the four hangars at the Dax Helicopter Museum experienced significant damage to metal sheeting covering the roof (Source: AIR)

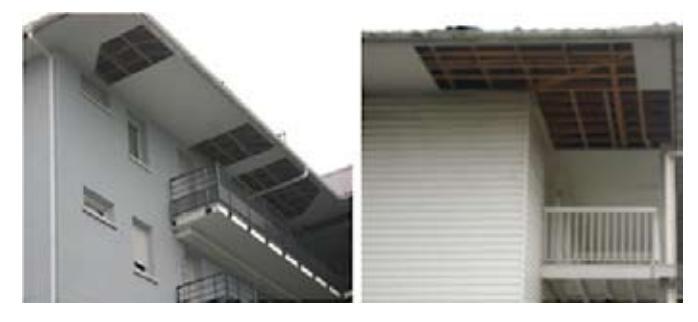
The most noticeable damage to residential properties in Dax occurred to the roofs of taller apartment buildings (four to five stories), where tiles at the roof ridge or eves had been blown off or displaced. In some cases, structures with large overhangs experienced damage to the soffits. Wind can become trapped under these overhangs, creating turbulence and large localized wind loads. Overhang damage can lead to more significant failure of the overall roof of a building, though this was not observed. More extensive structural damage to residential properties was observed in a few cases where large trees had been uprooted and had fallen onto houses.

Figure 10. Roof overhang damage in Dax (Source: AIR)

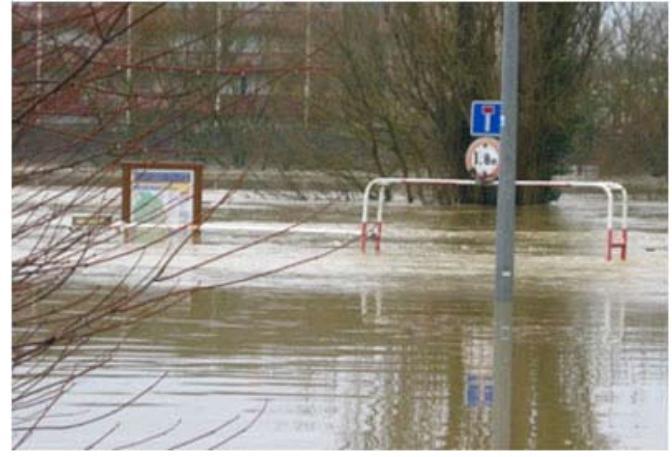
From Dax, as the team travelled east and inland from the coast, property damage was increasingly less frequent and typically limited to the roof tiles of older houses in states of poor repair. Tree damage decreased as well. However, the team observed significant flooding on the way from Dax to Salies de Bearn. The River Adour had burst its banks, flooding nearby roads (Figure 11). In some places, floodwaters were still threatening residences, although in no instance did the team actually observe flooded properties.

Figure 11. In and around Dax, the River Adour had burst its banks, flooding nearby roads (Source: $\mbox{AIR})$

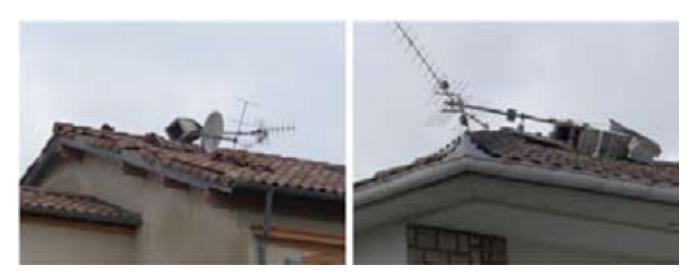
In the rural areas surrounding Toulouse, residential construction is predominated by low-rise unreinforced masonry buildings with low pitched, gable roofs. Common in this area are "canal" roof tiles, curved clay tiles that are overlaid in an overlapping pattern to hold them in place. Because they are not mechanically attached to the roofs, these tiles are typically the first to suffer damage during a windstorm. Corners and ridges experience the highest wind loads and indeed these damage patterns were the ones observed most frequently in the field. Newer roofs that featured flatter, more angular tiles with a lower profile fared much better. There were also instances of toppled chimneys, antennas, and satellite dishes (Figure 12).

Figure 12. Damage to canal roof tiles outside of Muret (left) and in Villefranche-de-Lauragais (right) (Source: AIR)

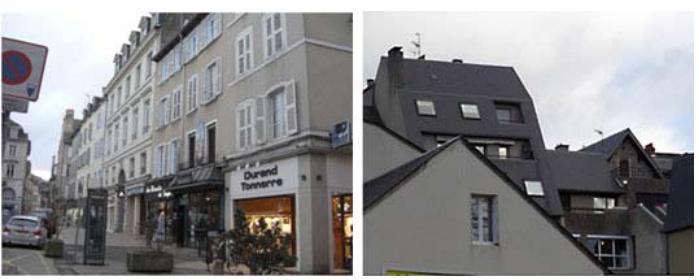
North of Toulouse, observed damage levels were consistent with the lower reported wind speeds here. Toward Rodez (about 150 km northwest of Toulouse), buildings were typically newer and constructed of concrete masonry and interlocking slate roof tiles (Figure 14). Despite the taller profile of the buildings and higher elevation of the town, minimal damage was seen.

Figure 14. More modern construction and lower wind speeds resulted in minimal damage in Rodez (Source: AIR)

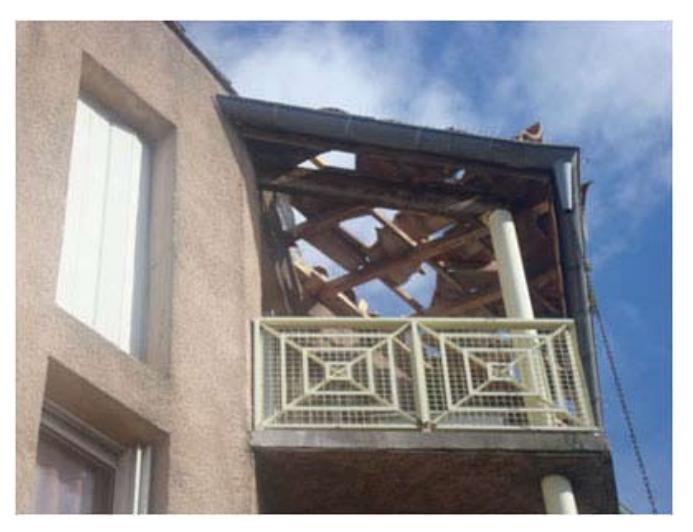
As the team travelled southeast from Toulouse, they observed an increase both in the severity and frequency of damage, which is again consistent with Klaus' recorded wind speeds. The incidence of damage was estimated at around to 1 in 20 buildings in Carcassonne (about 100 km to the southeast), where the team observed roof and overhang damage to residential buildings and a few incidences of structures damaged by fallen trees. However, commercial buildings in Carcassonne, which are generally of low-rise masonry wall construction with light metal roofs, escaped largely unharmed.

Figure 15. Non-structural damage to balcony awning. (Source: AIR)

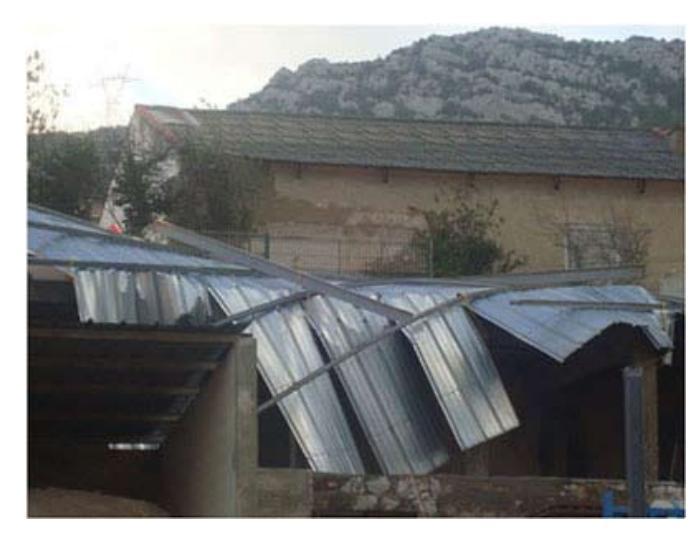
About 70 km southeast of Carcassonne, St. Paul de Fenouillet, which is situated atop an exposed hill in a large valley in the Pyrenees, experienced some of the highest wind speeds recorded during the storm—up to 177 km/h. Here, the incidence of damage was considerably higher, at around 1 in 10. Roof damage in St. Paul de Fenouillet was more severe than observed in previous areas, with large section of tiles damaged in some cases. There was also significant damage to commercial structures. These were of similar construction observed elsewhere in the region, but appeared to be noticeably older (Figure 16).

Figure 16. Roof and siding damage to a low-rise commercial structure in St. Paul de Fenouillet (Source: AIR)
